Title: 3D Shape Scanning and Structural Integrity Analysis to Advance Meniscus Allograft Transplantation

Background: Meniscus allograft transplantation can restore knee function yet remains vastly underutilized due to challenges in tissue matching and integrity assessment. Current tissue bank practices rely on 2D measurements and subjective inspections, which are inadequate for capturing complex 3D geometry and subtle defects. A cost-effective, efficient, and accurate system for 3D shape matching and structural integrity assessment could significantly improve graft selection, reduce surgical complications, and enhance transplantation success.

3D Shape Scanning and Structural Integrity Analysis to Advance Meniscus Allograft Transplantation

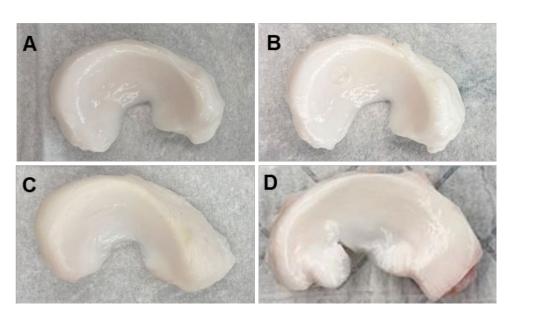
Fig. 2. Challenges in detecting and quantifying the subtle meniscal surface defects using the naked eye. (A) Intact meniscus; menisci with various defects a 10-mm longitudinal tear (D).

- 2D geometry measurement methods cannot capture complex 3D geometry.
- Graft evaluation relies on 2D photographs and visual inspection, which is subjective and unreliable (Fig. 2).

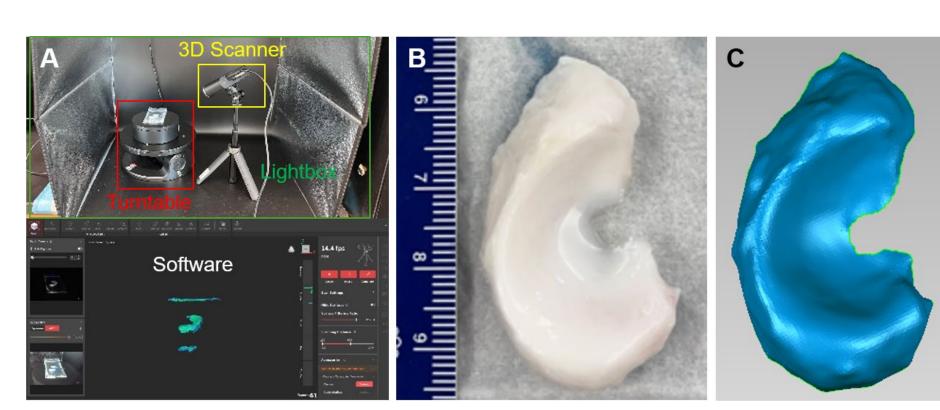
Fig. 3. 3D scanning hardware and software system. (A) The 3D scanning setup for a meniscus in the PBS solution within a transparent bag (top) and the software (bottom). A porcine meniscus sample (B) and its 3D scanned geometry (C).

- The system consists of a photo studio light box, a motorized turntable, and a stereo depth-sensing 3D camera. This setup enables consistent illumination and rotation of the specimen, allowing a complete 360-degree meniscus scan in approximately 30 seconds (Fig. 3). The system outputs interactive STL models that can be rotated, measured, and analyzed for both geometric accuracy and surface integrity.
- Custom software was developed with a Qt-based graphical interface and VTK visualization. Using curvature algorithms implemented with Libigl, the software computes principal and derived curvature measures, generating color-coded defect maps directly on the scanned model (Fig. 4).

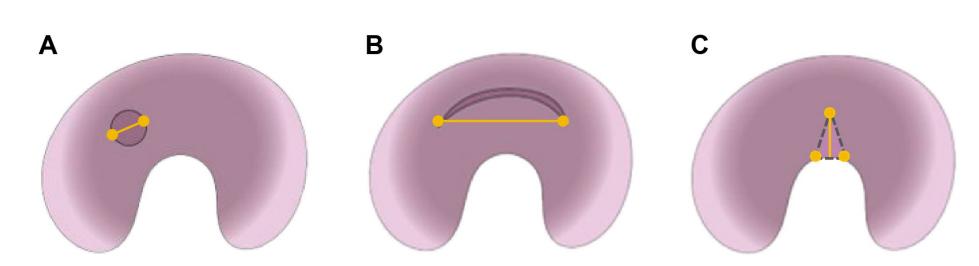
Fig. 6. Schematic of the detected defect modes.

- To examine defect detection, standardized defects were introduced in porcine menisci, including 5 mm diameter wear, 10 mm longitudinal tears, and 5 mm radial tears (Fig. 6). Stereomicroscopy measurements of these defects served as the ground truth.
- The scanned 3D geometries were analyzed using the curvature-based software, which highlighted regions of abnormal curvature and allowed interactive measurement of defect size.
- Two measurement approaches were implemented: a two-point method for longitudinal and surface defects, and a three-point method for radial tears. Detection results were compared against ground truth to evaluate accuracy and robustness (Fig. 6).

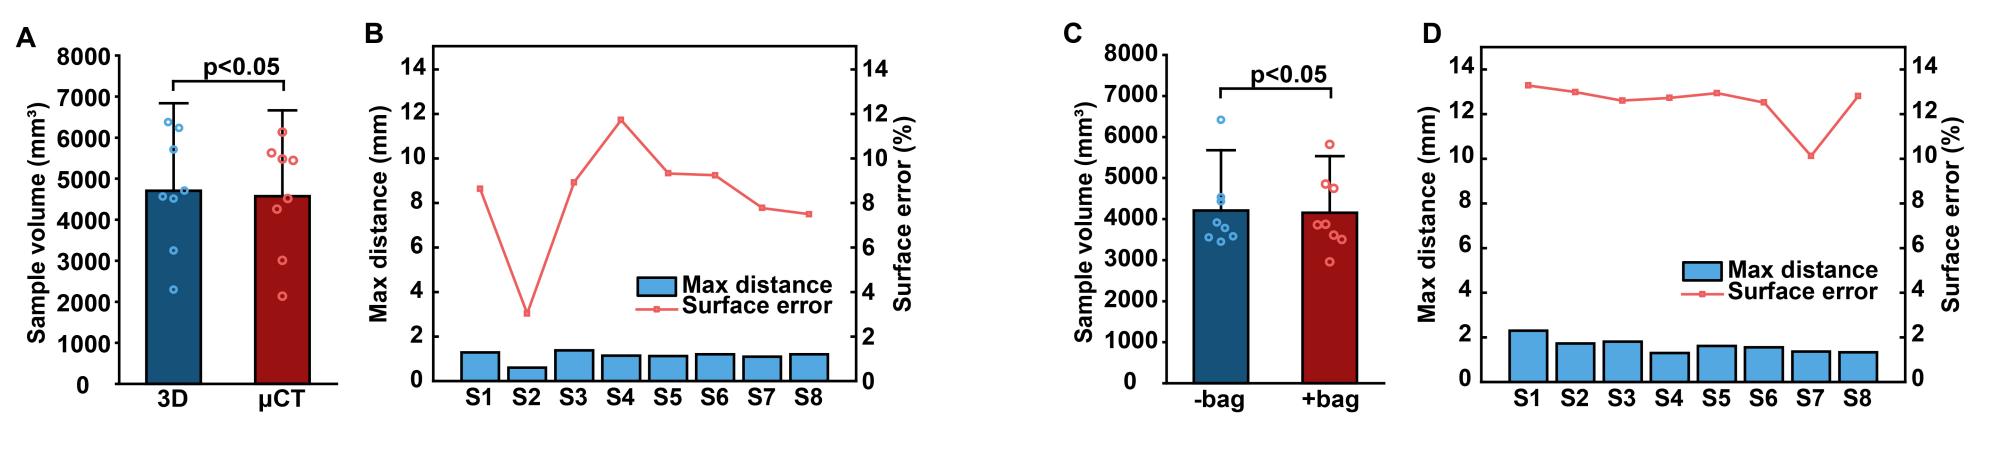
Fig. 7. Accuracy validation for volume and surface measurements. Comparison of volumes (A) and surface (B) obtained for the same samples using µCT and the 3D scanning system. Comparison of volumes (C) and surface (D) obtained for the same samples under air and preserved conditions using the 3D scanning system.

- Each scan was completed in ~2 minutes, compared to ~60 minutes required for μCT.
- The 3D scanner achieved a mean relative volume error of 6.9% and a mean surface deviation of 8.3% when compared with µCT models, with TOST confirming volumetric equivalence.
- When comparing scanner results obtained in air versus in PBS-filled sterile bags, the relative volume difference was 7.2% (TOST equivalence confirmed) and the mean surface deviation was 12.5%.

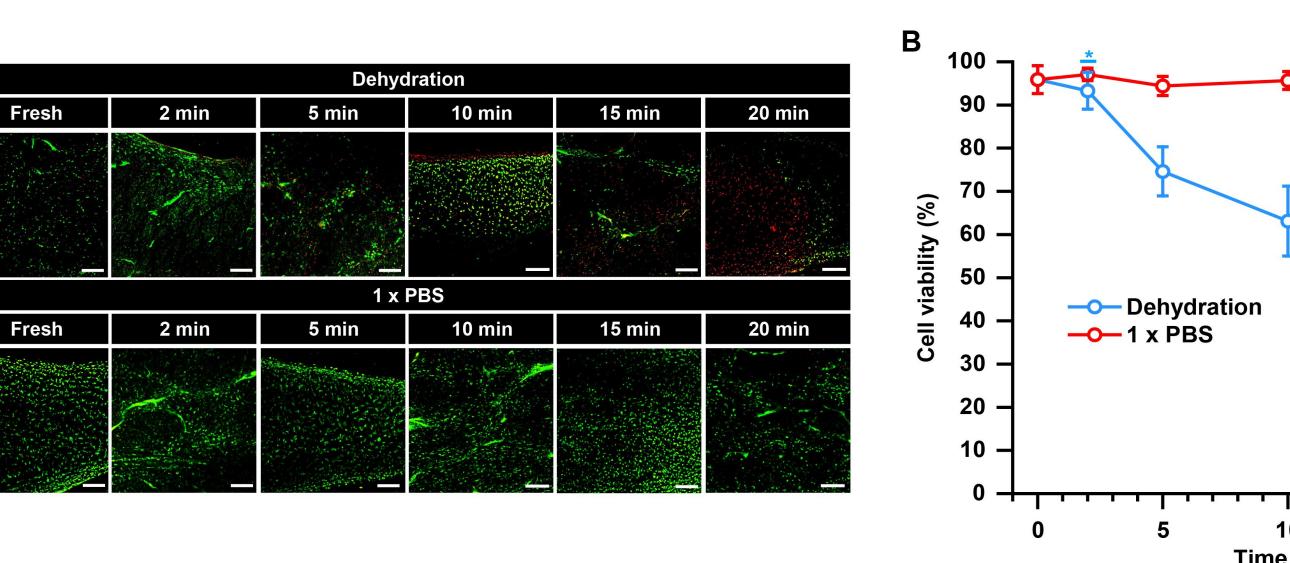
fluorescence images of tissues at defined time intervals. Green: Living cells; Red: Dead cells. Scale bar is 200 µm. (B) Quantitative analysis of cell viability based on image data.

- Live/dead imaging showed a rapid loss of viability in air-exposed menisci, dropping below the 70% clinical threshold after 10 minutes (63.1 ± 8.1%).
- In contrast, menisci stored in PBS retained >94% viability across 20 minutes, with no significant difference compared to freshly harvested tissue.
- These findings indicate that PBS immersion substantially prolongs the safe scanning window, whereas scanning in air is feasible only for very short durations.

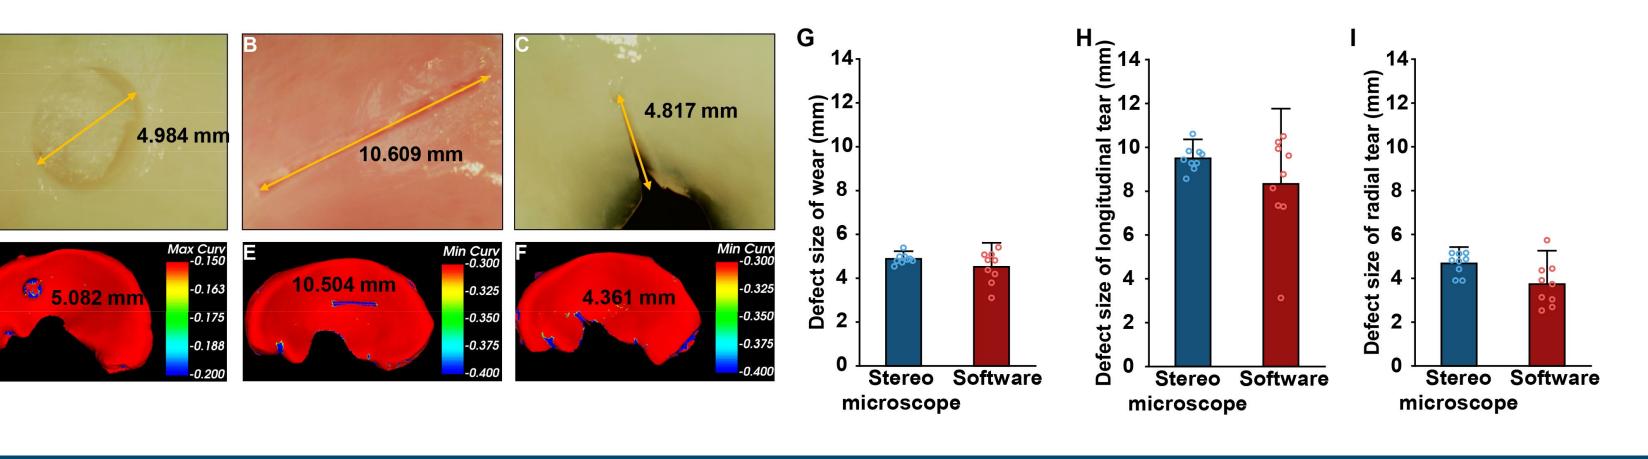
measurements between stereomicroscope and algorithm-based curvature software. (A-**C**) Representative measurements of three defects under the stereomicroscope. (D-F) Corresponding measurements of the same samples using our software. (G-I) Comparison in size measurements between the two methods across three defect modes.

- Three clinically relevant defect types (surface wear, longitudinal tears, radial tear) were consistently detected using curvature-based software.
- Optimal indicators were identified for each defect: maximum curvature for surface wear, and minimum curvature for both longitudinal tears and radial tears.
- Surface wear and longitudinal tears achieved statistical equivalence with stereomicroscopy within ±20% bounds, while radial tears showed the largest deviations from ground truth.
- Overall, the system enabled accurate, reproducible defect detection and measurement with minimal user input, demonstrating strong potential for integration into tissue bank workflows.
